# Rock Island Preservation Commission

## REPORT

SUBJECT: Case #2011-3 – Consideration of a Certificate of Appropriateness for 1614-34 18<sup>th</sup> Avenue, which is also known as Longview Condominiums

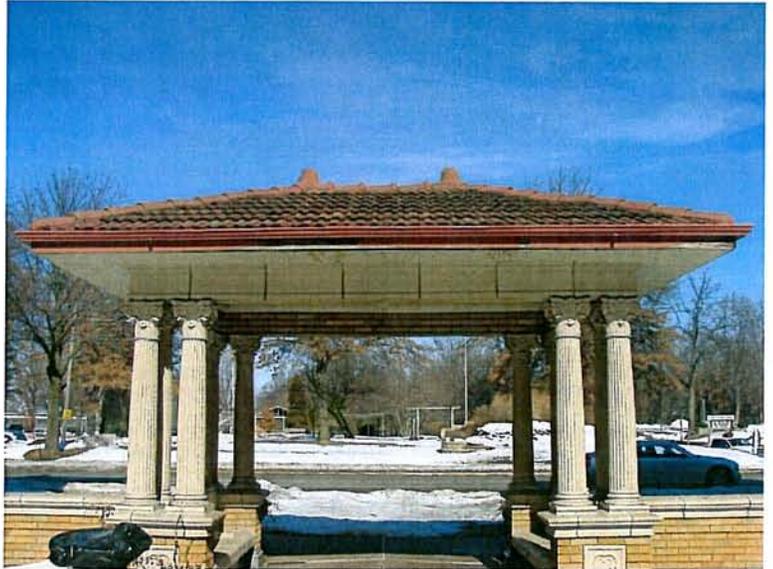
Longview Homeowners Association Board Member Steven Schrock has submitted an application for a Certificate of Appropriateness to remove the historic tile roof on the courtyard gazebo of Longview Apartments, constructed in 1927 and designated a Rock Island Landmark in 1990. The application includes a request to replace the tile roof with a stone-coated metal roof system.

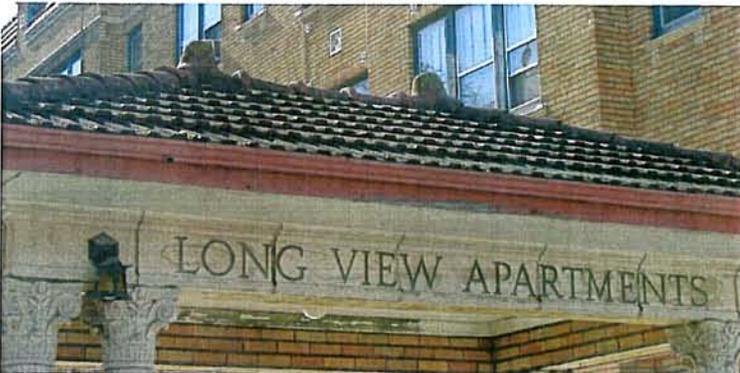
The extent to which the homeowners' association has investigated the condition of the existing tile roof is unknown. Staff is also unsure of whether the homeowners' association has consulted with experienced tile roof restoration companies or ascertained the availability of replacement tiles.

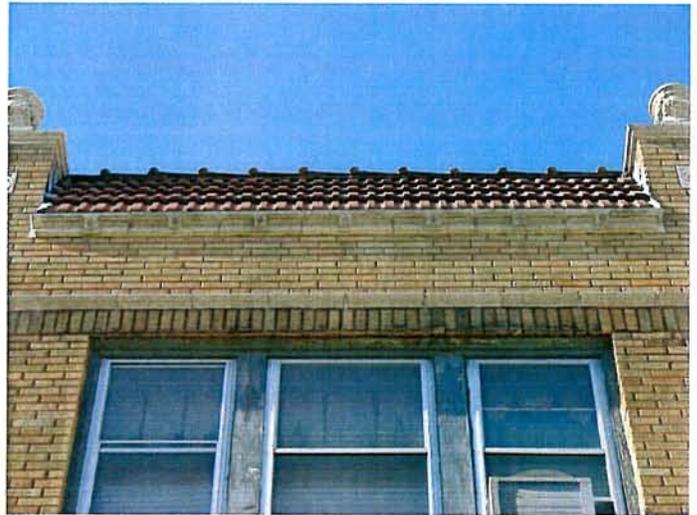
It should also be noted that matching tiles exist in 12 steep-pitched panels along the Longview Apartments roofline visible from 18<sup>th</sup> Avenue.

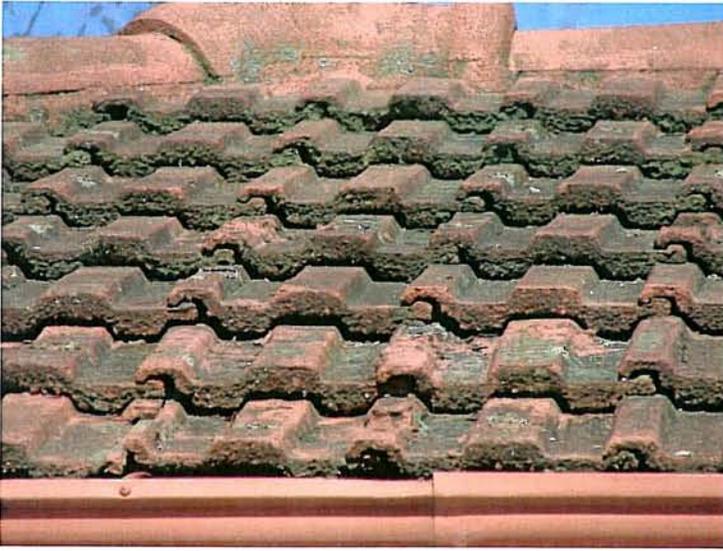
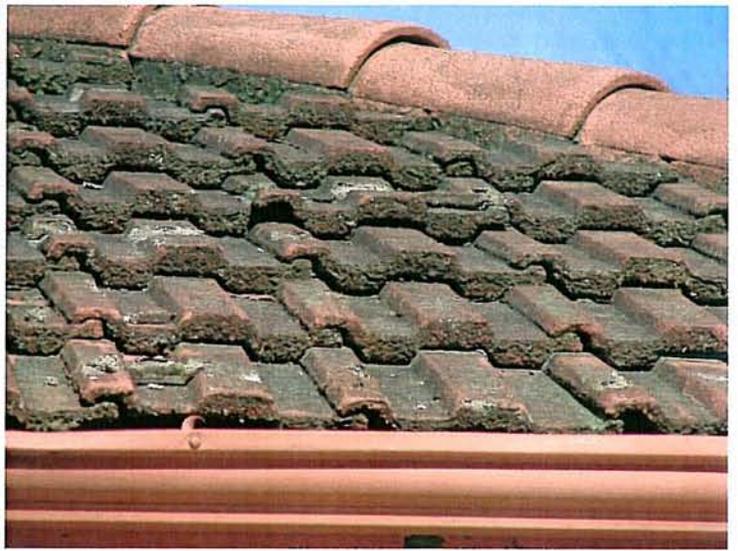
Finally, staff searched the archives of Forum-L, the list-serve for the National Trust for Historic Preservation, and found only one reference to stone-coated steel tiles. In this single instance, the local commission determined that the entire roof could not be removed because only about 10 tiles were severely deteriorated. There was not a debate on the modern material. The absence of commentary about stone-coated shingles is curious, given the often lengthy discussions of modern replacement materials on the Forum-L. The applicants are requesting the use of the Classic style tile, in Barcelona color. However, the examples in the catalog appear to have a straighter edge pattern than the "Classic Tile Stock Colors" and the example used at Advanced Construction, which appear to have scallops. The scalloped edge would not be compatible in appearance with the existing historic tiles. However, the depth and profile of the steel tile is similar to the historic tile.

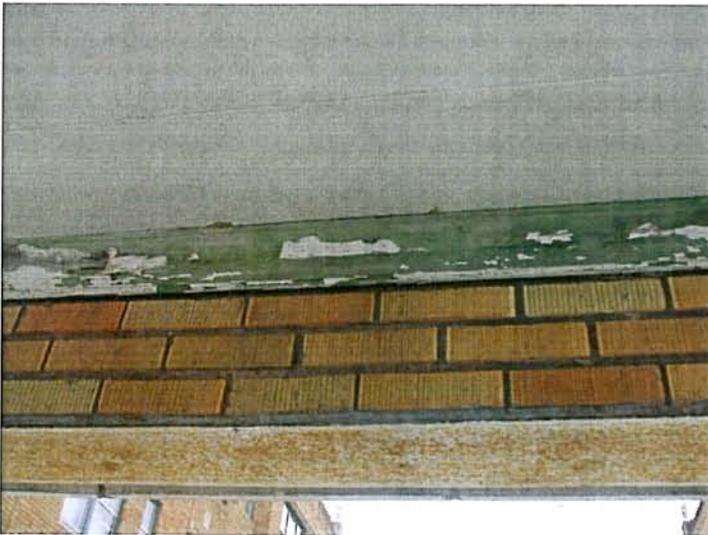
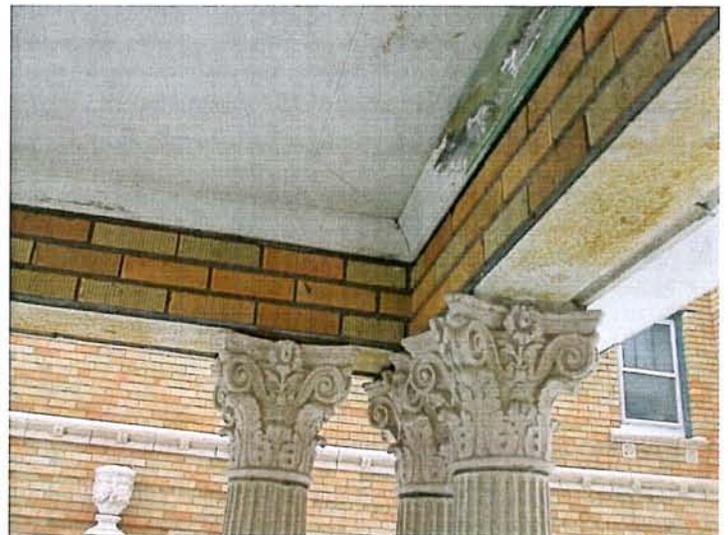
Staff feels that complete removal of the historic tile cannot be supported and is contrary to both the *Residential Design Guidelines* and the Secretary of the Interior's Standards for Rehabilitation. However, there is no doubt that there are damaged tiles and some limited leaking is occurring. The close-up photos above show the tiles on the south side. The other three sides are in much better condition. But, it is also staff's opinion that the gazebo structure is not in imminent danger of collapse. It is also true that from the underside, much of damage appears to be in the vicinity of the soffit. The City's Housing Rehabilitation Officer concurs with this assessment. More photos will be available for viewing at the meeting.

Staff recommends the Preservation Commission deny the Certificate of Appropriateness for removal of the gazebo roof tiles and their replacement with stone-coated steel tiles. Further, staff recommends the Commission urge the applicants to revise and resubmit their application, following a course of action outlined below:

1. Secure the services of an experienced tile roof restoration company to conduct an assessment of the tile condition and underlying roof structure.
2. With the assistance of the restoration experts, attempt to locate salvaged replacement tiles.
3. Remove and clean the tiles.
4. Relocate tiles in good condition to the north, west and east sides of the gazebo roof.
5. If modern replacement tiles are needed, they should be used only on the south side of the roof, which is the least visible from public right-of-way.
6. The historic barrel tiles on the hip and the specialty tiles on the ridge should be reinstalled.

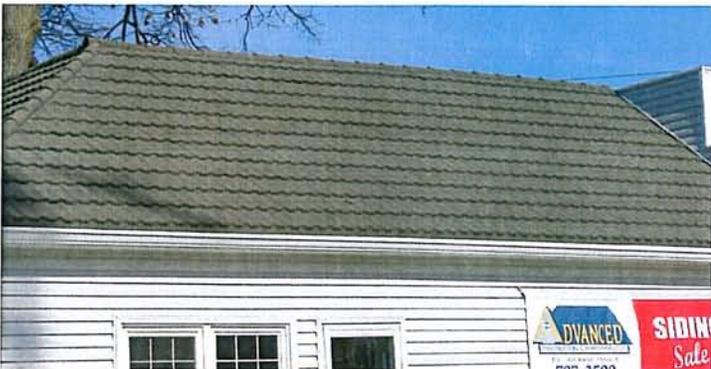
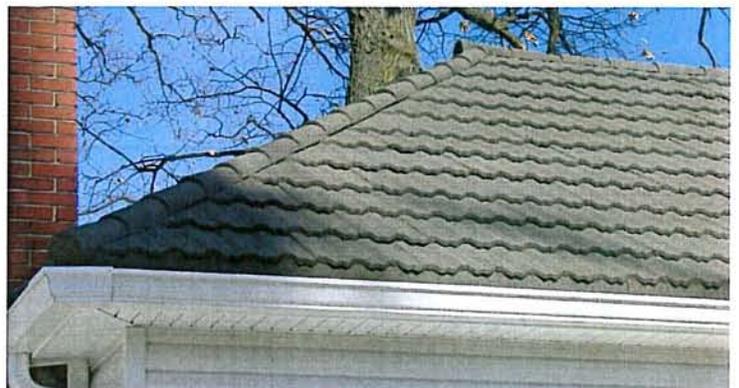
Below are photos of the suggested Classic Tile (different color) on the Advanced Construction building in Moline.

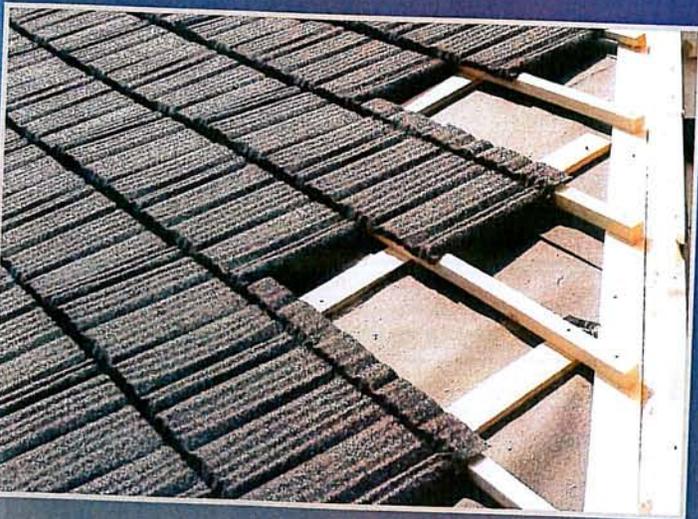
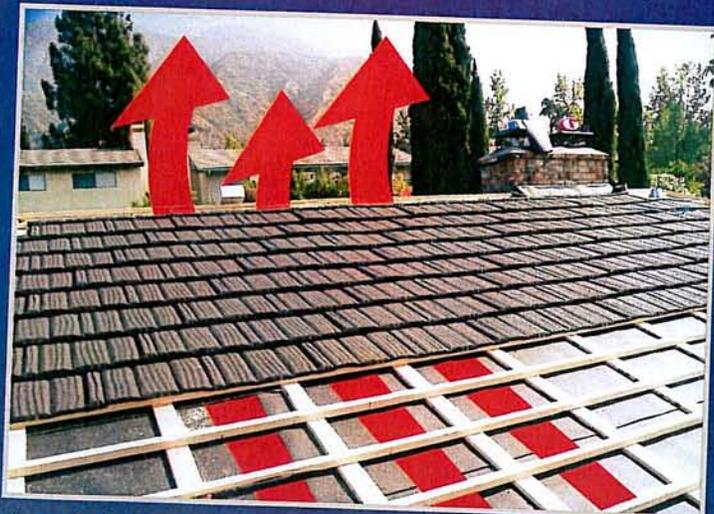
Allowing **hot air** to escape substantially reduces heat gain. The Batten System allows free air to pass between the roof deck and metal panels.
